Manhole Inspection Summary

Manhole # S21GG2005MH

Insp Date: **11/9/06 2:59 PM**

Location Address: **1115 BRYN MAWR RD**

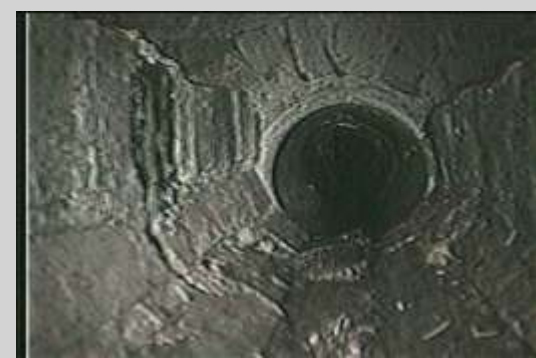
8 in. Circular Gravity Sewer Pipe Out @ 12 O'Clock

Pipe Material: **Clay** ☐ Pipe Lined

Infiltration: **None** Pipe Seal Cond: **Unknown**
